The levadas and their implications for the dynamics of the slopes in the north of Portugal

The Levada do Piscaredo, as a human topographic signature (Taroli; Sofia, 2016), highlights the impacts generated on the slopes and valley floor, since its implementation in the 17th century, until the daily maintenance and the major renovation of 1970 (map 2). Originally, the canal was 5,600 meters long, from the dam/dam on the old river to the irrigated areas, receiving an additional 1,500 meters to connect the levada to an increase in flow at the confluence of the Cabril and Cabrão rivers.

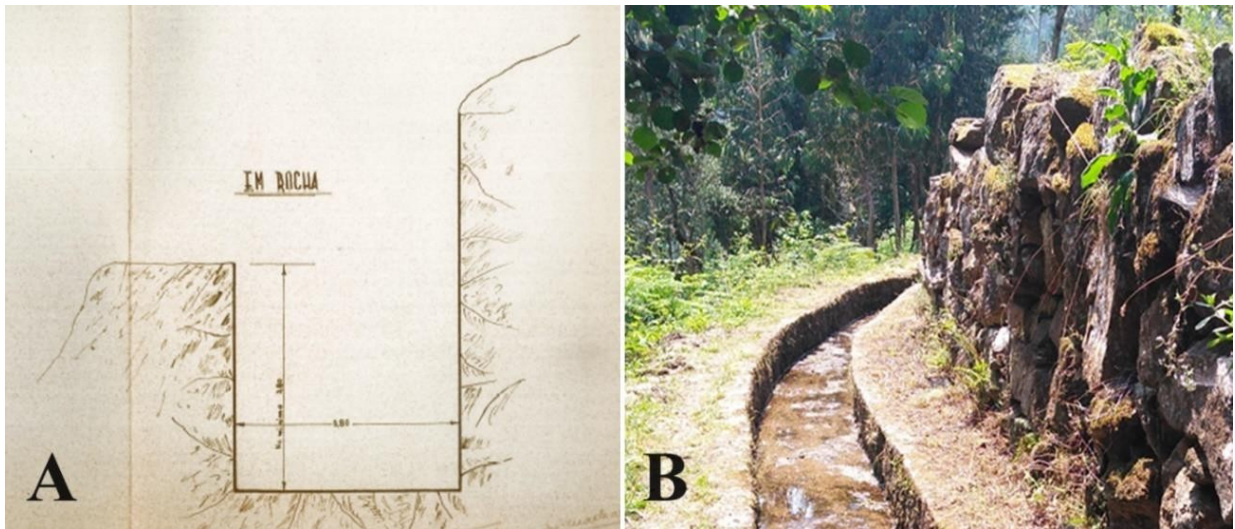
Panel 1- A: Cut in the rocky slope for installation of the levada. In the diagram it is possible to notice that the cut was made in order to accommodate the flow and avoid spills. B: Cut in granite rock and accommodation of the channel cover.

The levada was opened in rocky slopes, directing water and sediments from the valley bottoms to the slopes. Interventions were carried out in these channels to capture, contain or redirect surface flows from the slopes. These structures combine changes in the dynamics of the slopes by both catalyzing and mitigating erosion and deposition processes (Panel 1).

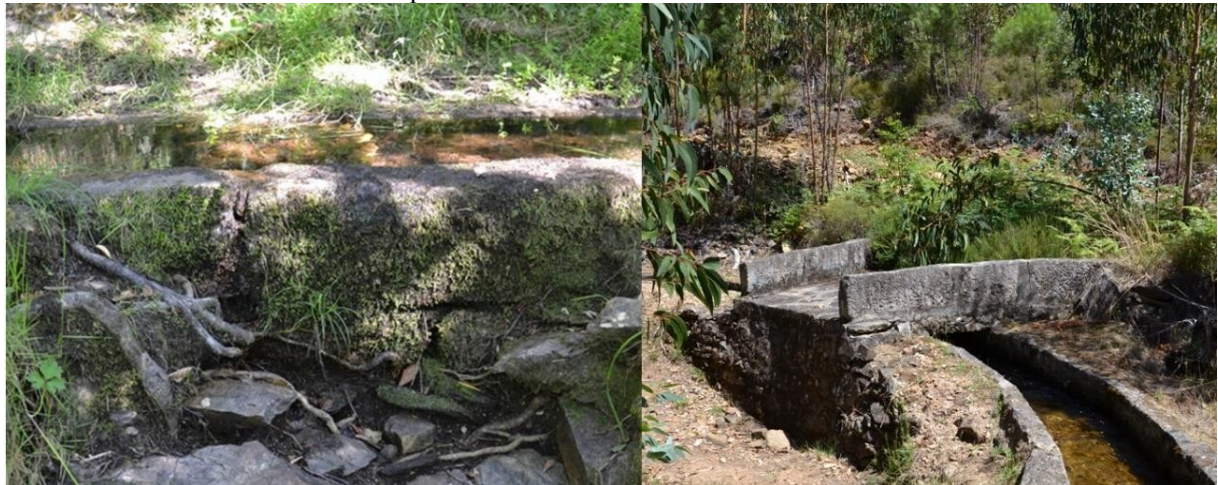
Panel 2 - Canal passage in a narrow section with erosion threatening the structure. And gutter to isolate flows from the slopes of the artificial canal

In some sections, erosion processes or the rocky material of the slope conditioned narrow passages to the artificial channel (Panel 2), requiring the

construction of support barriers to ensure that the structure would not be lost due to erosion processes. These barriers are rustic, generally made of cut and fitted stones or masonry bricks.

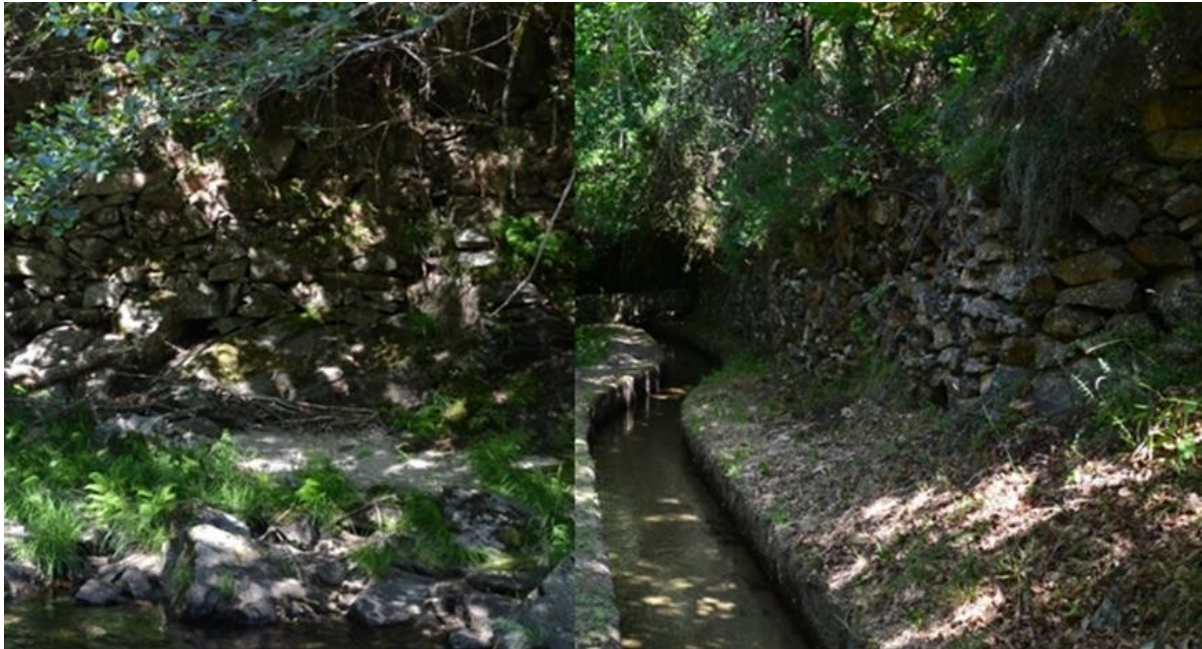
Panel 3 - Stone wall installed in the upper part of the slope stabilizes the structure of the artificial channel, while reducing the risk of collapse due to the river activity of the Cabril River in the lower part.

In one of the sections, there are approximately 1,200 meters of support walls from the channel to the lower portion of the slope. Also in the upper portion of the slope, long walled sections were built to reduce the risk of landslides, which are more susceptible to surface cutting and the passage of water (panel 3).

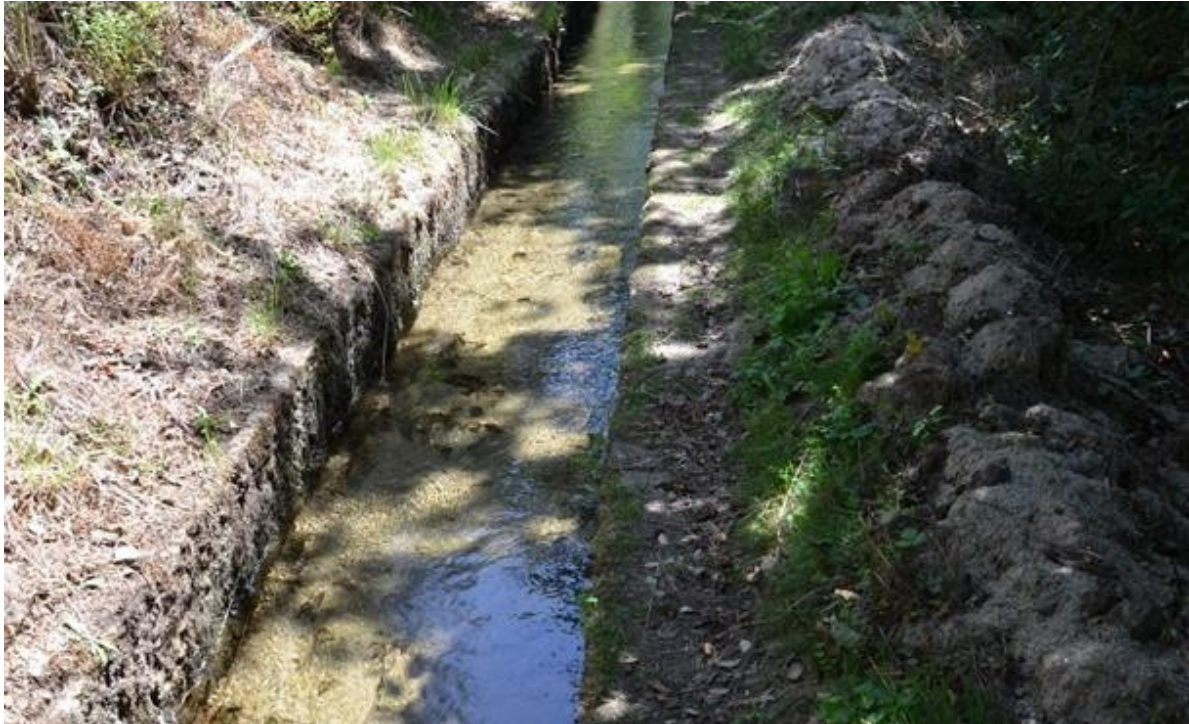
Photo 1 - Sedimentary material deposited in the channel that has its transport capacity reduced during periods of low flow.

Regarding the processes that develop within artificial channels, sedimentation is the most prominent, although the structure based on impermeable plates facilitates flow and reduces deposition. However, seasonal cleaning is necessary, as sediment deposition advances in some sections with less slope and consequent reduction in flow speed (photo 1). From the removal of material within the channel, small marginal deposits are formed that, when consolidated on the channel banks, form the so-called anthropogenic marginal dikes (Silva, 2018).
